Manhole Inspection Summary

Manhole # S53AA_028MH

Insp Date: **7/17/08 8:15 AM**

Location Address: **3201 mcelderry st**

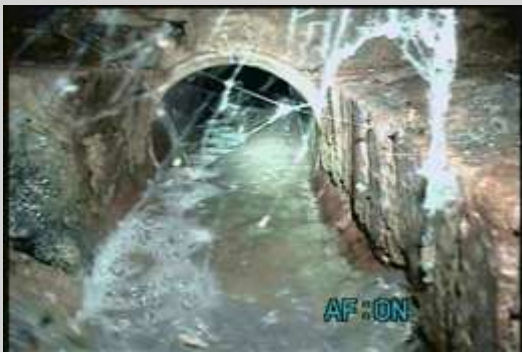
12 O'Clock Outflow

8 in. Circular Gravity Sewer
Pipe Out @ 12 O'Clock

Pipe Material: **Clay** ☐ Pipe Lined

Invert Depth: **8.44** (ft.) Flow Characteristics: **Fast**

Deposits: ☒ None ☐ Mud ☐ Sludge ☐ Debris ☐ Grease

Infiltration: **None** Pipe Seal Cond: **Unknown**

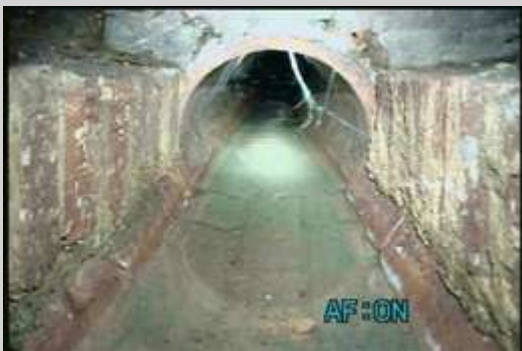
6 O'Clock Inflow

8 in. Circular Gravity Sewer
Pipe In @ 6 O'Clock

Pipe Material: **Clay** ☐ Pipe Lined

Invert Depth: **8.28** (ft.) Flow Characteristics: **Slow**

Deposits: ☒ None ☐ Mud ☐ Sludge ☐ Debris ☐ Grease

Infiltration: **None** Pipe Seal Cond: **Unknown**

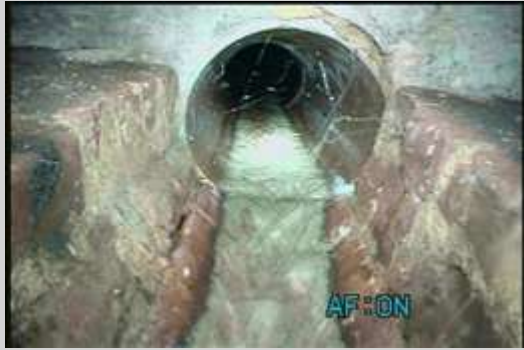
9 O'Clock Inflow

8 in. Circular Gravity Sewer
Pipe In @ 9 O'Clock

Pipe Material: **Clay** ☐ Pipe Lined

Infiltration: **None** Pipe Seal Cond: **Unknown**
